July 28, 2025

File No.: 2490 Rev.1

RE: Slope Stability Assessment Proposed Apartment Building

92 Northumberland Street, Ayr, Ontario

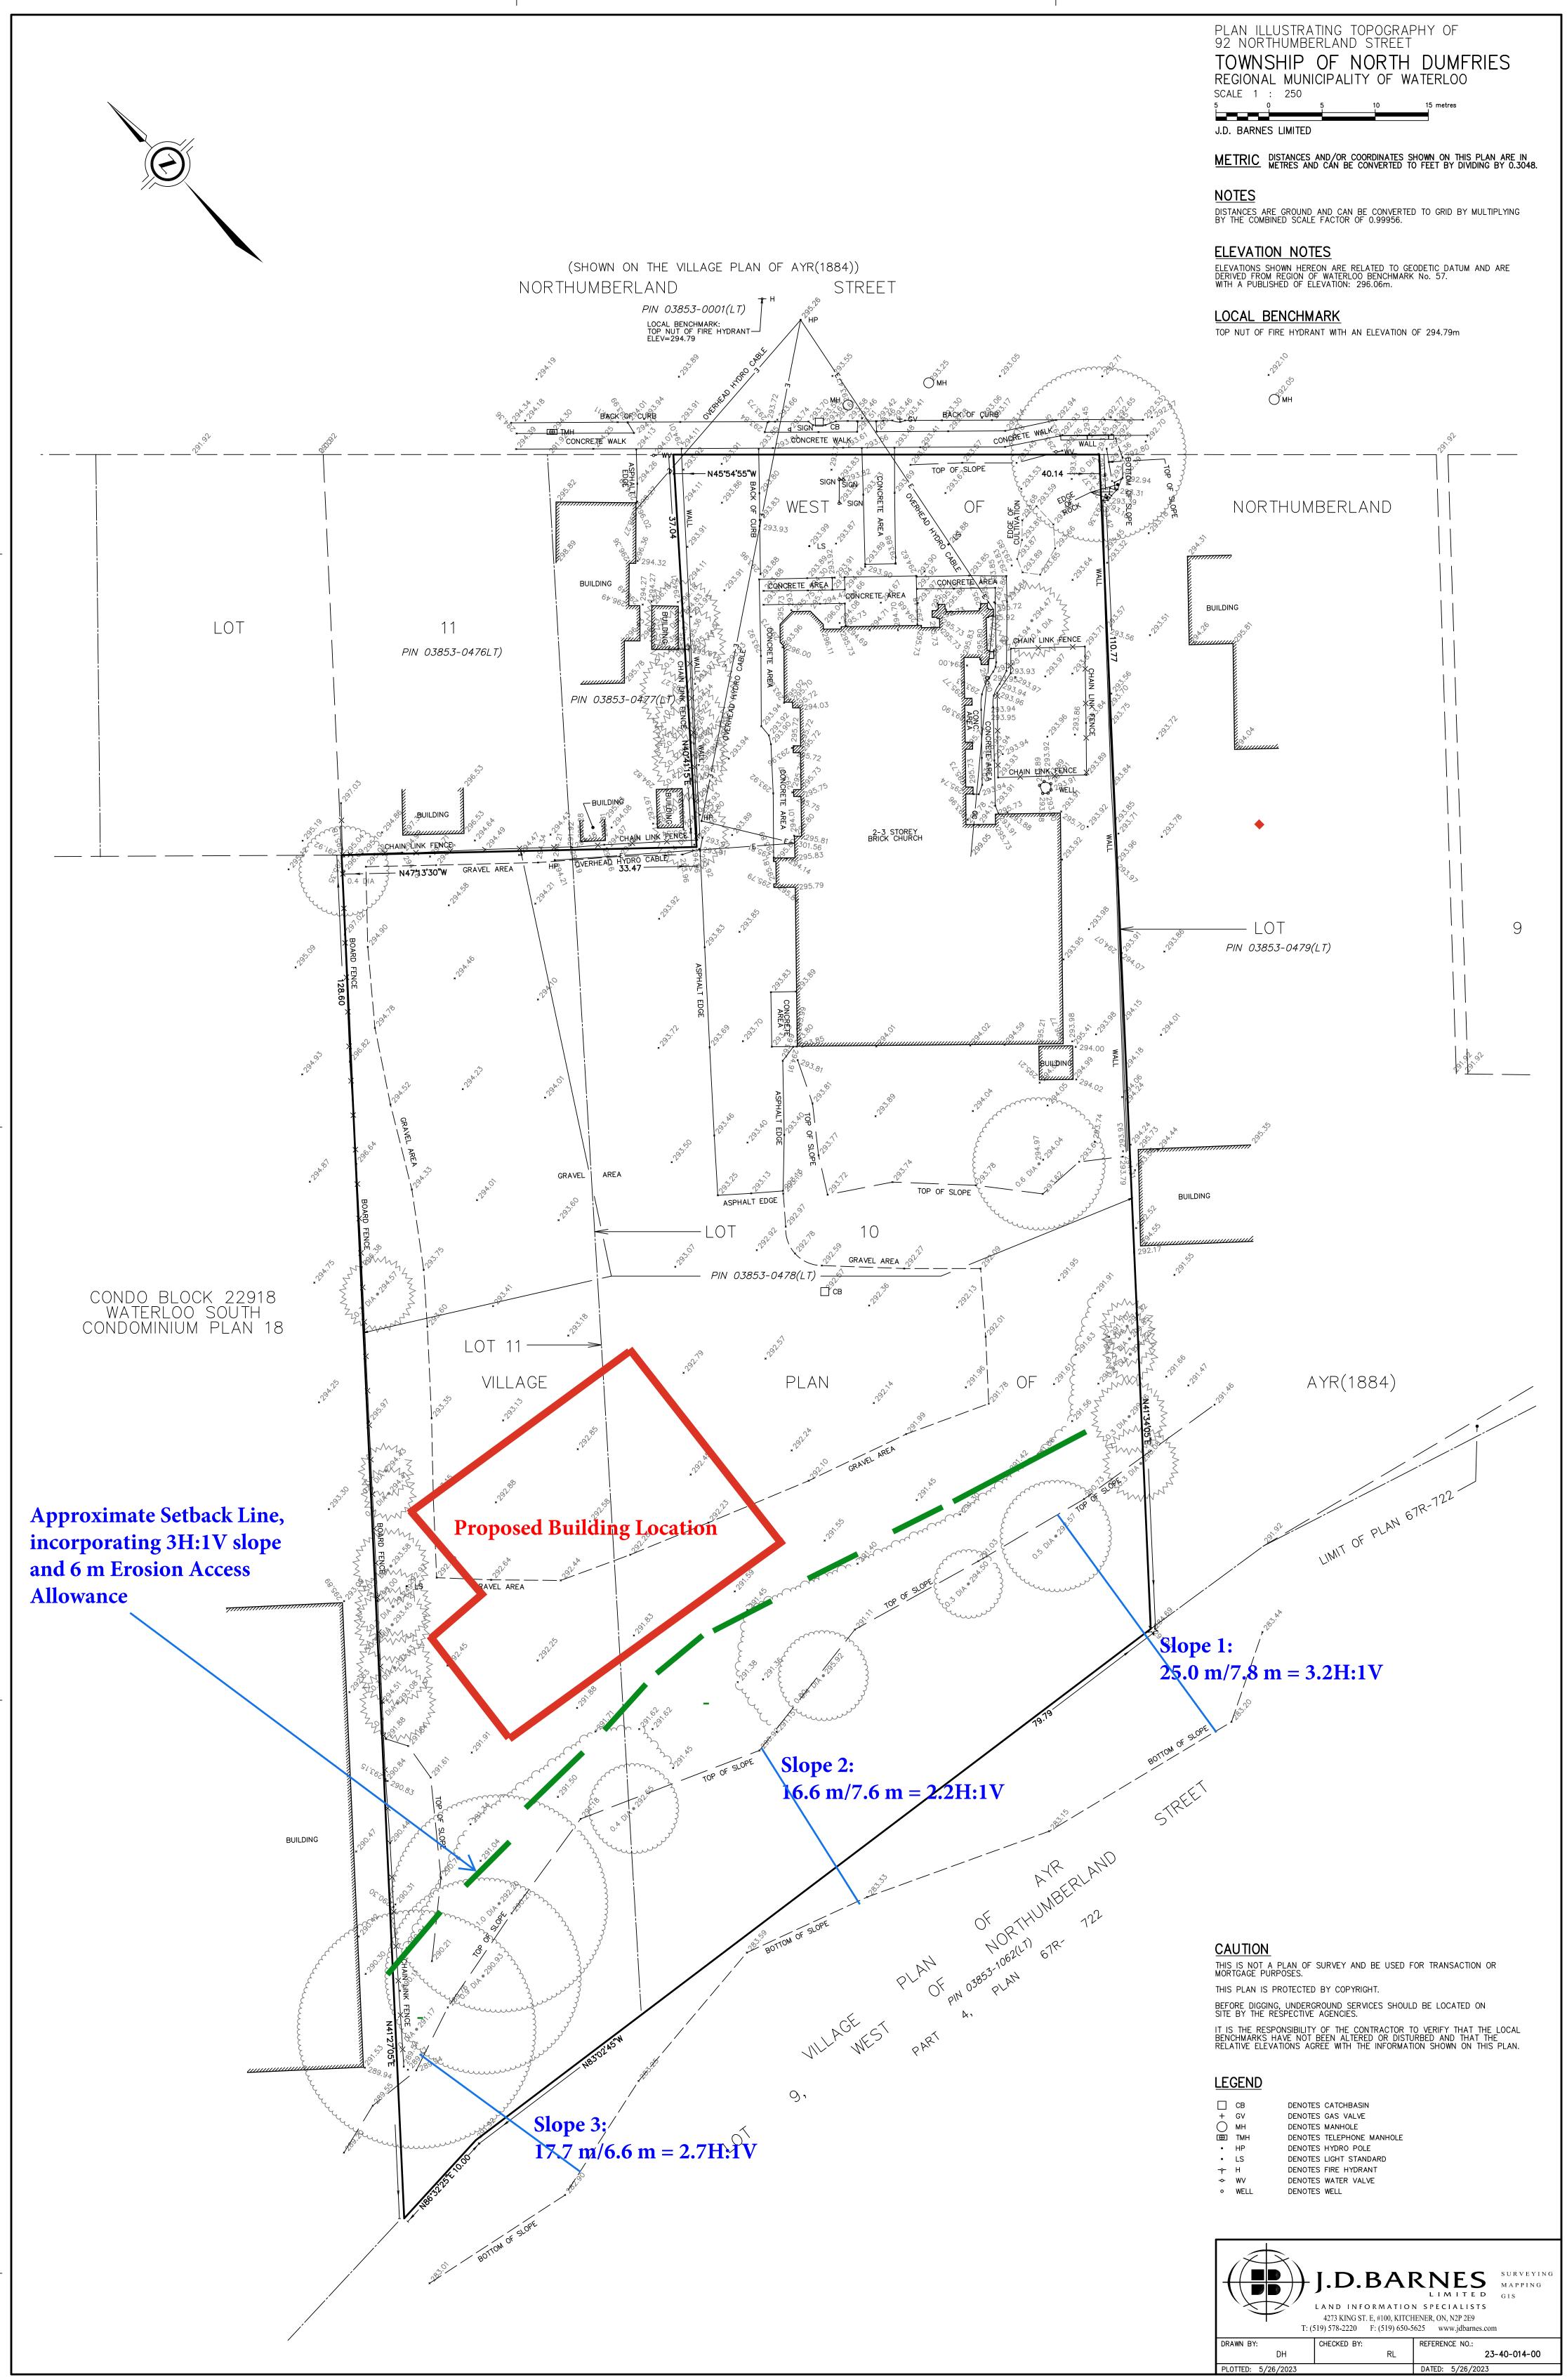
Topographical Plan with Setback Line

Three (3) slope sections, the southern portion, middle and norther portion, were selected to calculate the average slope inclination, and the locations of these sections are shown in Appendix C. The average inclinations of the slope are calculated from the spot elevations on the topographic plan and summarized below:

Slopes are considered to be stable when the slope inclination is 3H:1V or flatter. Therefore, the stable top of slope would be equal to a line having a distance of 3 times the height of the slope measured from the toe of the slope. The approximate setback line incorporating 3H: 1V slope and the 6 m Erosion Access Allowance is indicated on the topographic drawing in Appendix C.

With the proposed location of the building plotted on Appendix C, the recommended setback line is located within the 10 m "Environmental Buffer" from the present top of slope and therefore the proposed building location meets the GRCA setback requirement.

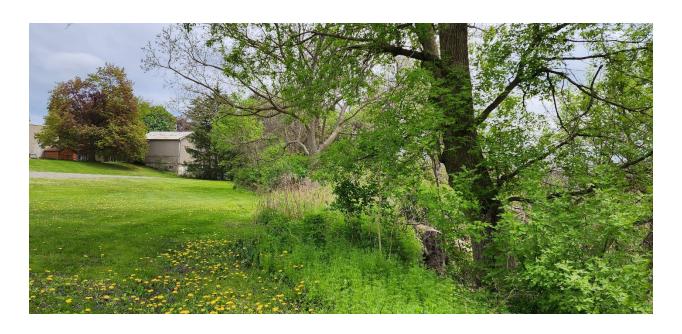
Southern, Slope 1:
 3.2 H: 1 V

Photograph 1, Southern portion of top of slope (Slope 1)

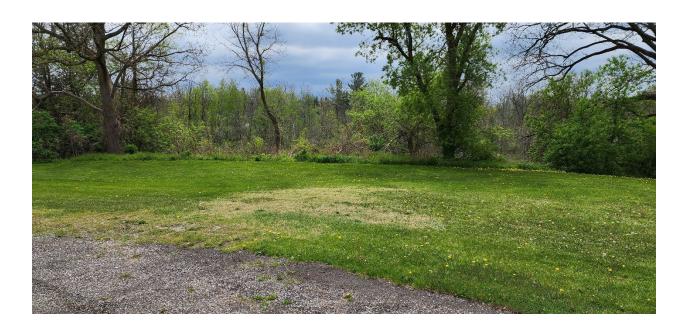
Middle, Slope 2:
 2.2 H: 1 V

Based on our observation, fill has been placed on the original/natural slope, as revealed by soil around the tree trunks and the steep slope (especially in the middle section).

Photograph 2, Middle portion of top of slope (Slope 2)

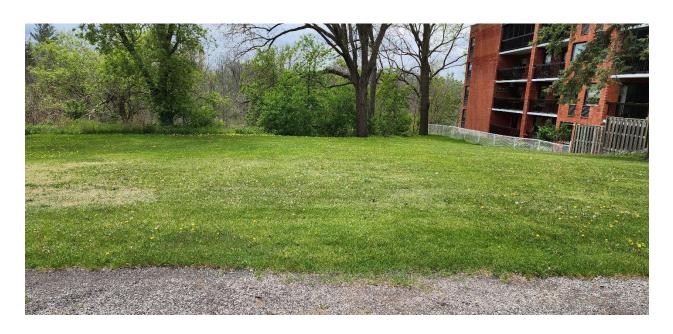
Northern, Slope 3:
 2.7 H: 1 V

Photograph 3, Northern portion of top of slope (Slope 3)

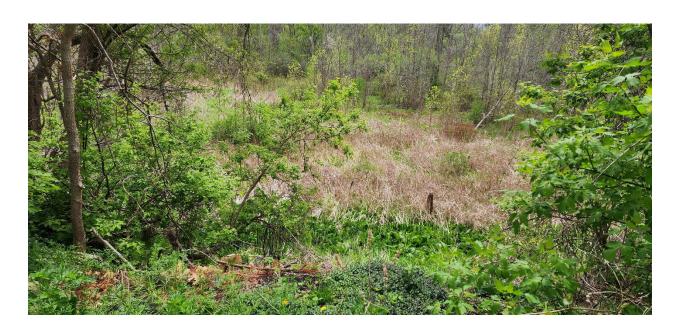
The slope surface is fully covered by vegetation and the top of the slope is lined with matures trees. There are no signs of present or past slope instability. No seepage weas observed on the slope surface and at the toe of the slope.

Photograph 4, View of flood plain from top of slope, slope surface fully vegetated

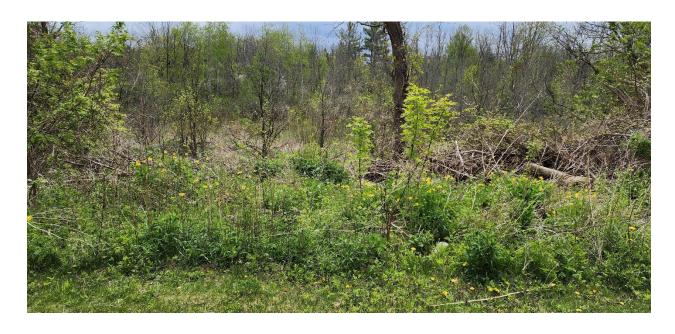
Photograph 5, View of flood plain from top of slope, slope surface fully vegetated

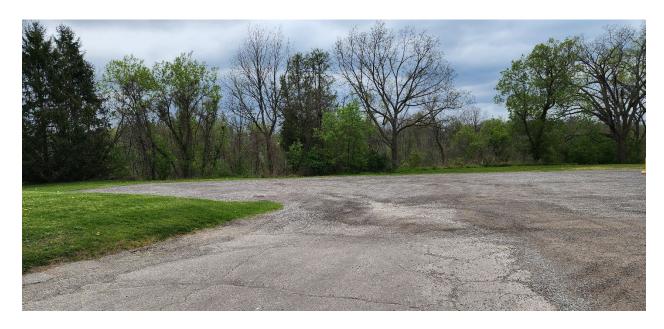
Photograph 6, View of middle portion of slope from parking lot, mature trees line the top of slope
