July 7, 2025

20-225(a).R01

**Re: Class IV Sewage Disposal System
Septic System Assessment
260 Waydom Drive,
Avr, Ontario**

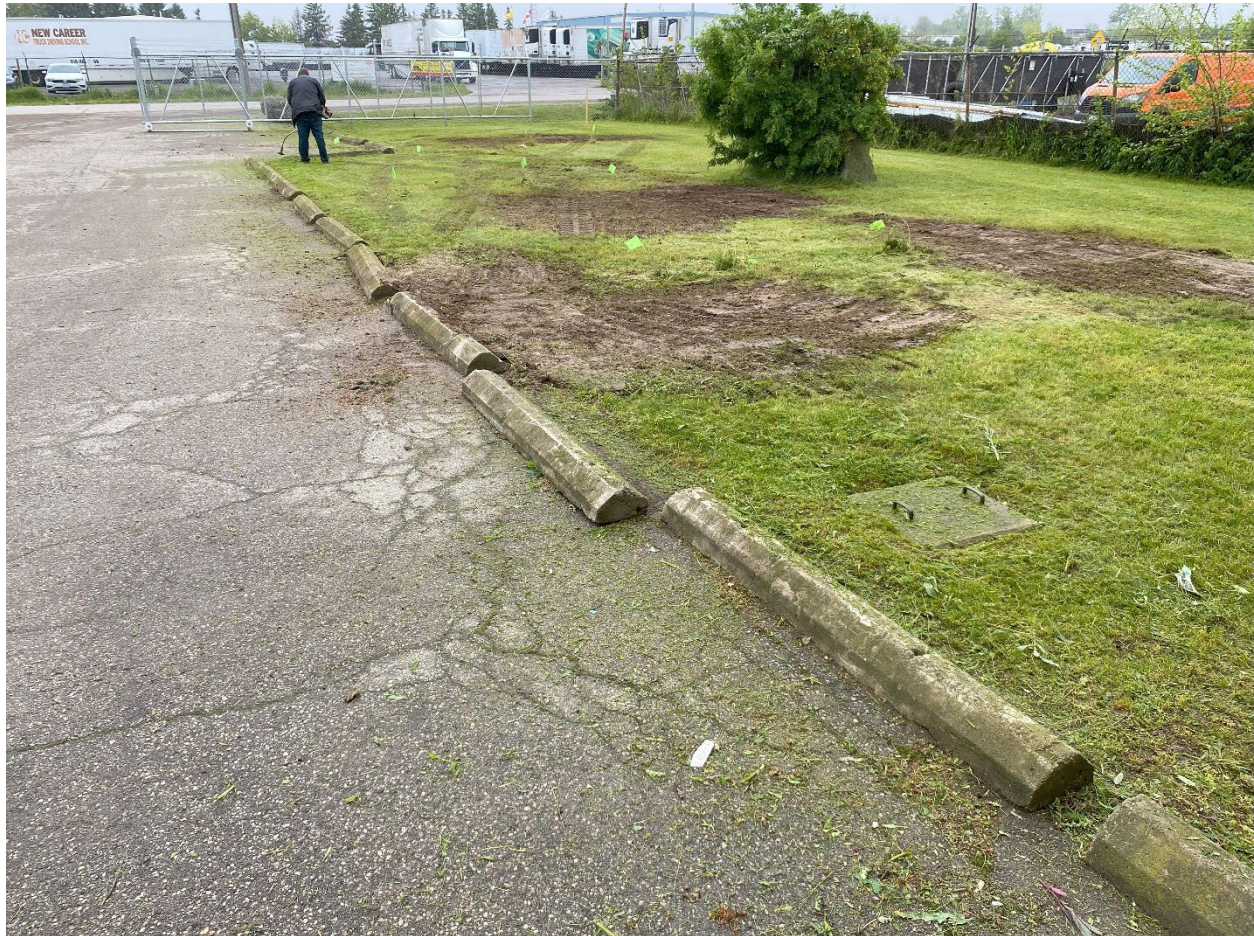
The distribution pipes within the leaching bed were located using ground penetrating radar. There did not appear to be any signs of saturation at the surface and no areas of sewage breakout. Portions of the header were exposed, as well as a portion of the footer. The leaching bed was observed to consist of in-ground absorption trenches, constructed with 75 mm diameter perforated PVC pipe surrounded by clear stone aggregate. There was observed to be approximately 0.8 m of soil cover above the absorption trenches. The leaching bed was observed to have seven (7) runs of absorption trenches. The distribution pipes within the absorption trenches were measured to be 15.24 m (50.0 ft) in length for a total of 106.68 m (350.0 ft) of absorption trenches. The header was surveyed and appeared to be generally level, within a tolerance of 6.4 mm (0.25 inches) over the entire header, which is considered satisfactory. The slope on the distribution pipes was surveyed and appeared to have a slope of 0.3% (4.5 cm over the 15.24 m length of distribution pipe), which is considered satisfactory. A test pit was completed within the leaching bed. The absorption trenches were observed to be in good condition, un-saturated, and very little bio-mat build-up. A sample of the native soil below the leaching bed was obtained and submitted to the CMT Inc. laboratory in St. Clements, Ontario for sieve analysis, soil classification and percolation time determination. The soil sample from a depth of 1.2 m (3.9 ft) in was determined to be sand and gravel, trace silt and clay, and has an estimated percolation rate (T-time) of 4 min/cm.

1 - Surface of leaching bed showing test pit excavation areas.

According to the equation $Q = 200L/T$, the leaching bed is designed to accept a daily sanitary sewage flow rate of 5,334 litres/day. As such, the leaching bed is considered satisfactory to remain and service the industrial building under the current usage. Overall, the absorption trenches appear to be in good condition and functioning as intended. The absorption trenches did not appear to have geotextile or building paper above the absorption trenches, and some fine material was observed to be infiltrating the clear stone within the absorption trenches. As well, a portion of the leaching bed was covered with an asphalt driveway. CMT Inc. cannot make a determination on the remaining service life of the existing septic system, however, the system is currently working as intended and is considered satisfactory to remain in service. The distribution pipes in the leaching bed maintain the required setback distances of 3.0 m from property lines, 5.0 m to structures, and 15.0 m from drilled wells.

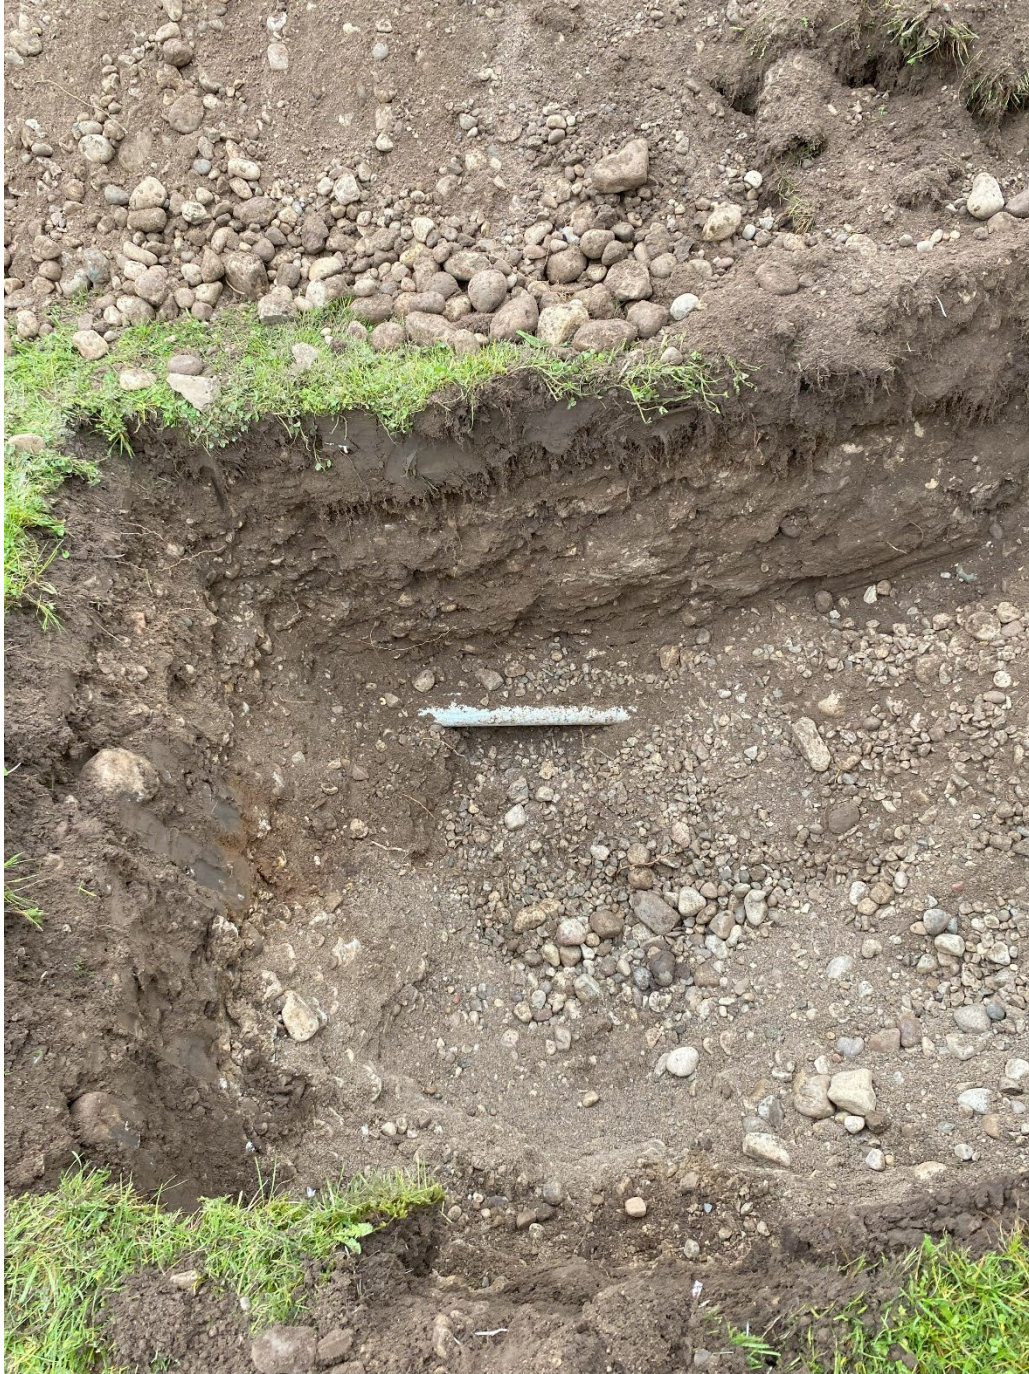
2 – Septic distribution pipe and native sand and gravel soil.

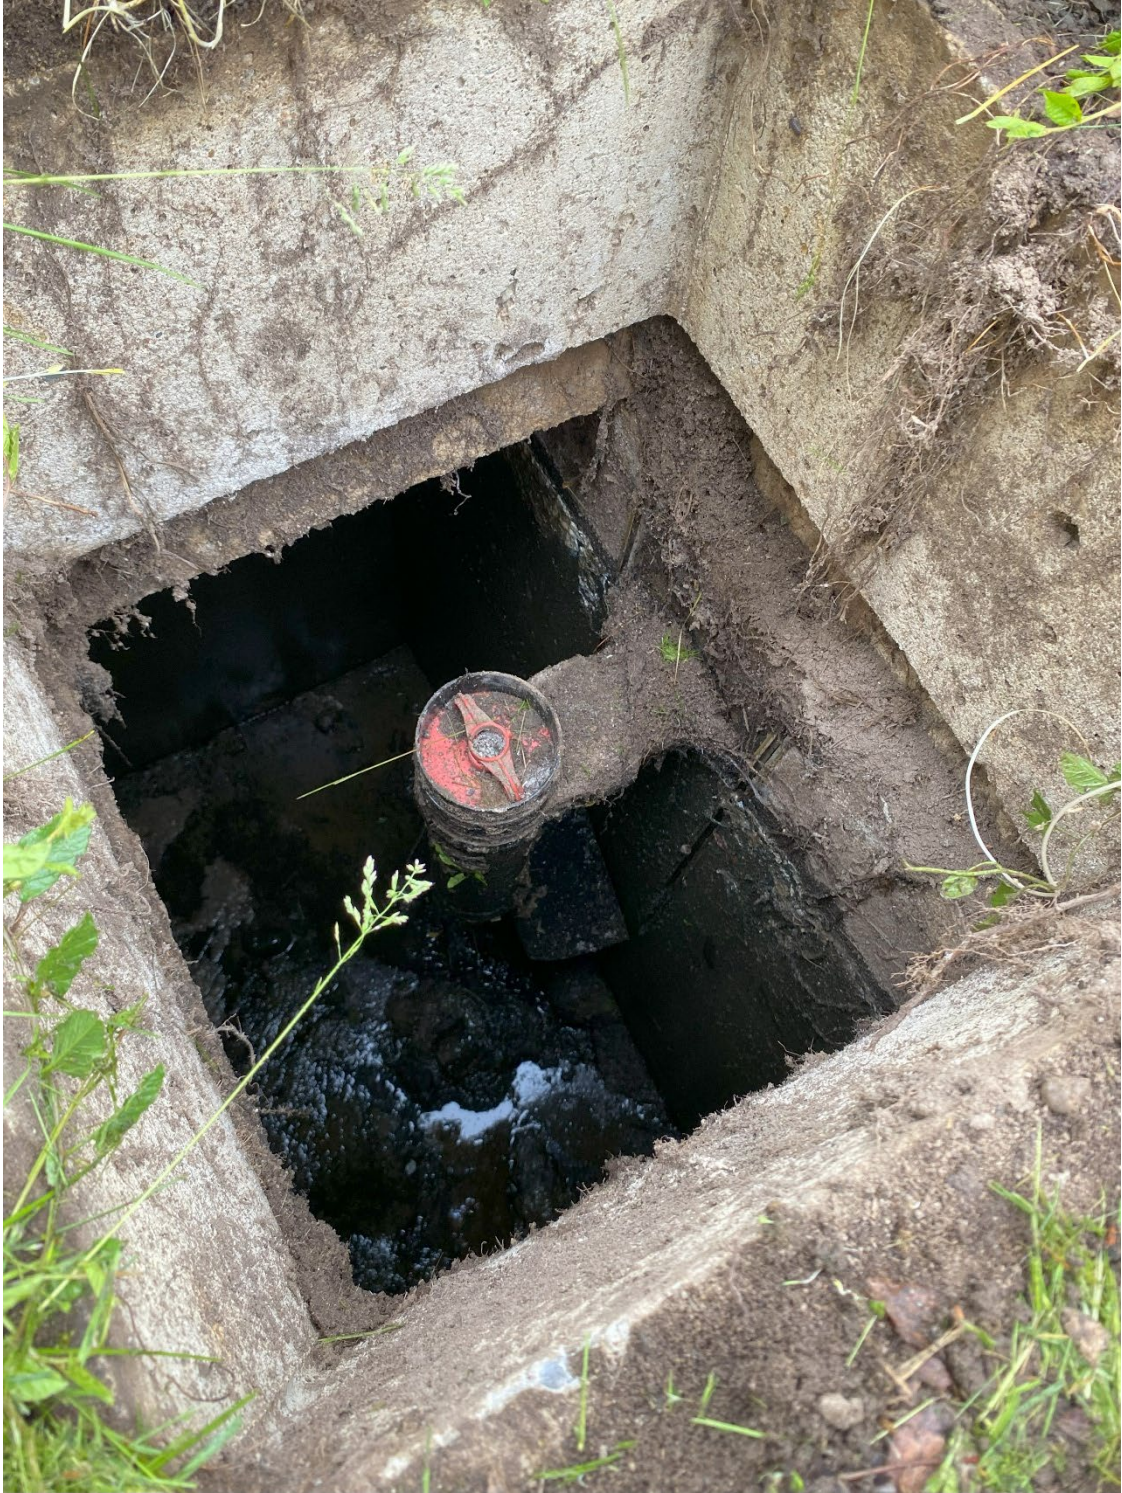
The septic tank lids were uncovered and opened to inspect the septic tank. The septic tank appeared to be in good condition with no spalling or corrosion of the inlet or outlet side of the septic tank. An inlet baffle was installed and an effluent filter was present on the outlet side of the tank. The tank was pumped out prior to inspection and it was reported to be a 3,825 litre (850 gal) septic tank. Based on the OBC 2024, the minimum working capacity of a septic tank must be the greater of 3,600 litres or three times the daily design sanitary sewage flow for non-residential occupancies. Three times the total design flow of 375 litres for the industrial building would provide a minimum working capacity of 1,125 litres. As such, the existing septic tank with a capacity of 3,825 litre (850 gal) is considered satisfactory to service the existing industrial building.

3 – Septic tank outlet side with effluent filter.
