| <i>WHISTLE BARE ROAD<br/>CAMPGROUNDS</i> |
| <i>1898 WHISTLE BARE ROAD</i> |
| <i>PRELIMINARY GRADING PLAN</i> |

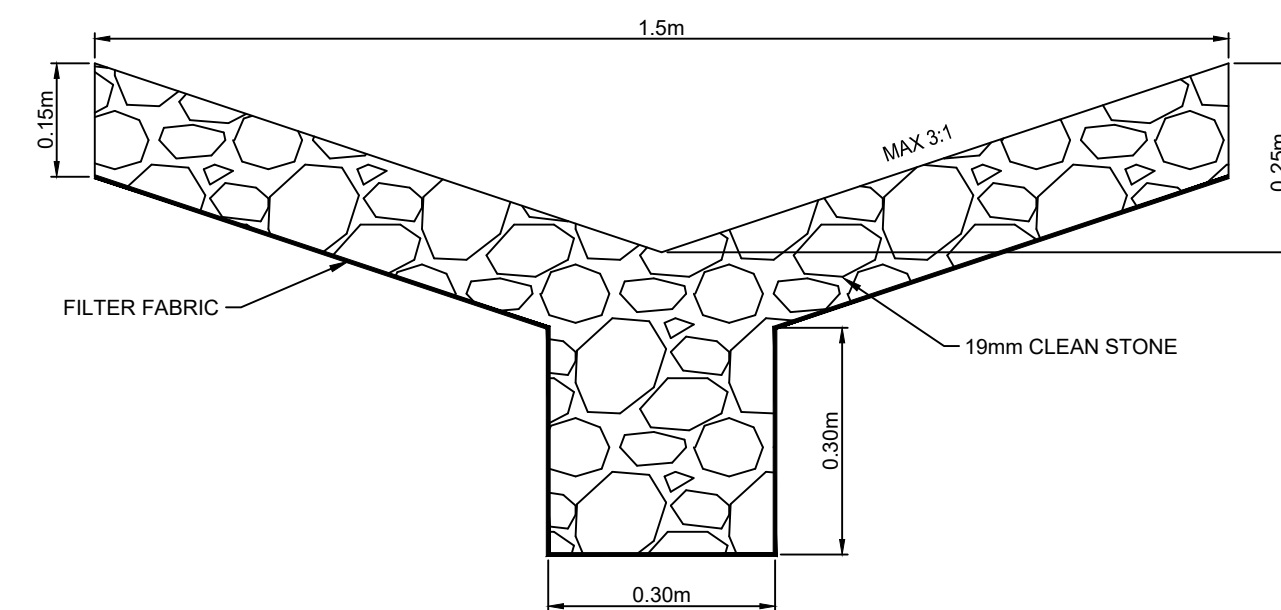
TYPICAL DITCH DETAIL  
NOT TO SCALE
